LARGE NAVIGATIONAL BUOY ENGINE-GENERATOR
TEST PROGRAM. PART I. TECHNICAL DISCUS-
SION AND CONCLUSIONS

R-72-019
July 1972

FINAL REPORT
LARGE NAVIGATIONAL BUOY
ENGINE-GENERATOR TEST PROGRAM

PART 1
TECHNICAL DISCUSSION AND CONCLUSIONS

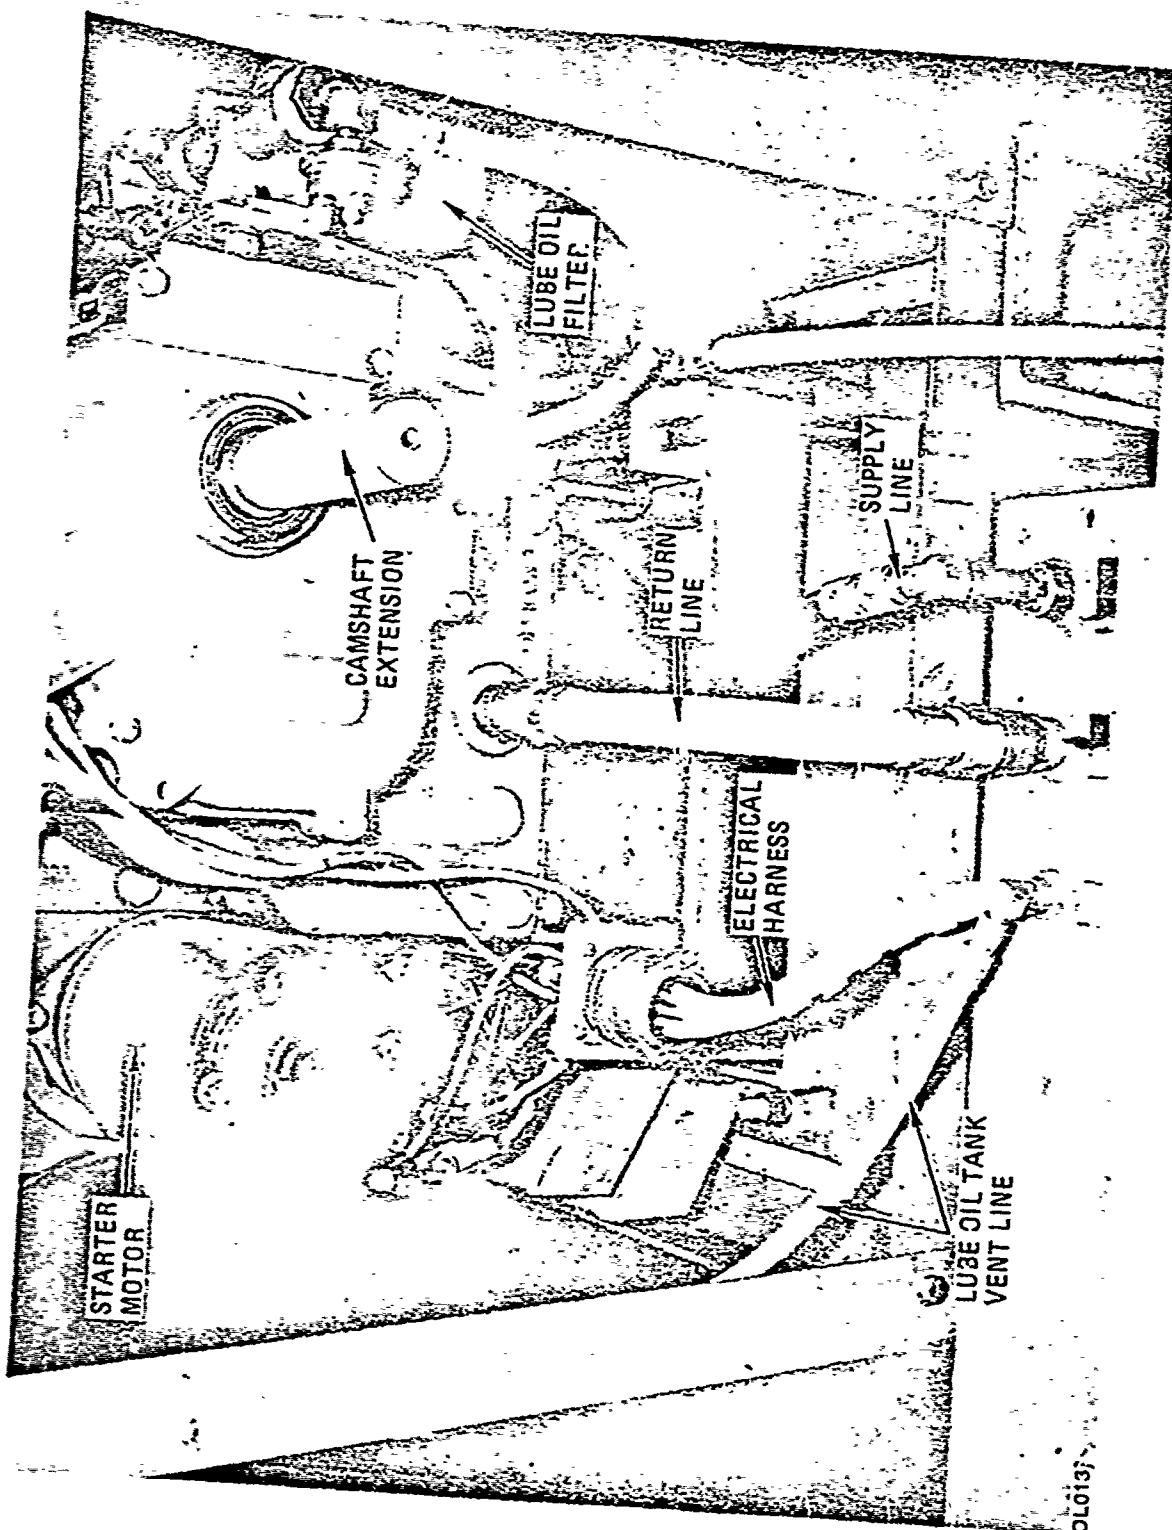
Figure 4-1. Final Lube Oil Line Arrangement

Cause — Investigation subsequent to the failure showed an abnormal amount of lubricating oil present in the engine crankcase. During operation, the crankcase was found to contain 5 quarts of lubricating oil, whereas the normal sump crankcase capacity is only 5 pints. The oversupply of oil had caused excessive loading and overheating of the engine. The overheating had, in turn, caused failure of the camshaft oil seals.

Corrective Action — The symptoms of the failure were as noted. The cause of the failure was traced to insufficient drainage capability from the crankcase to the externally mounted lube oil reservoir. Corrective action was taken to:

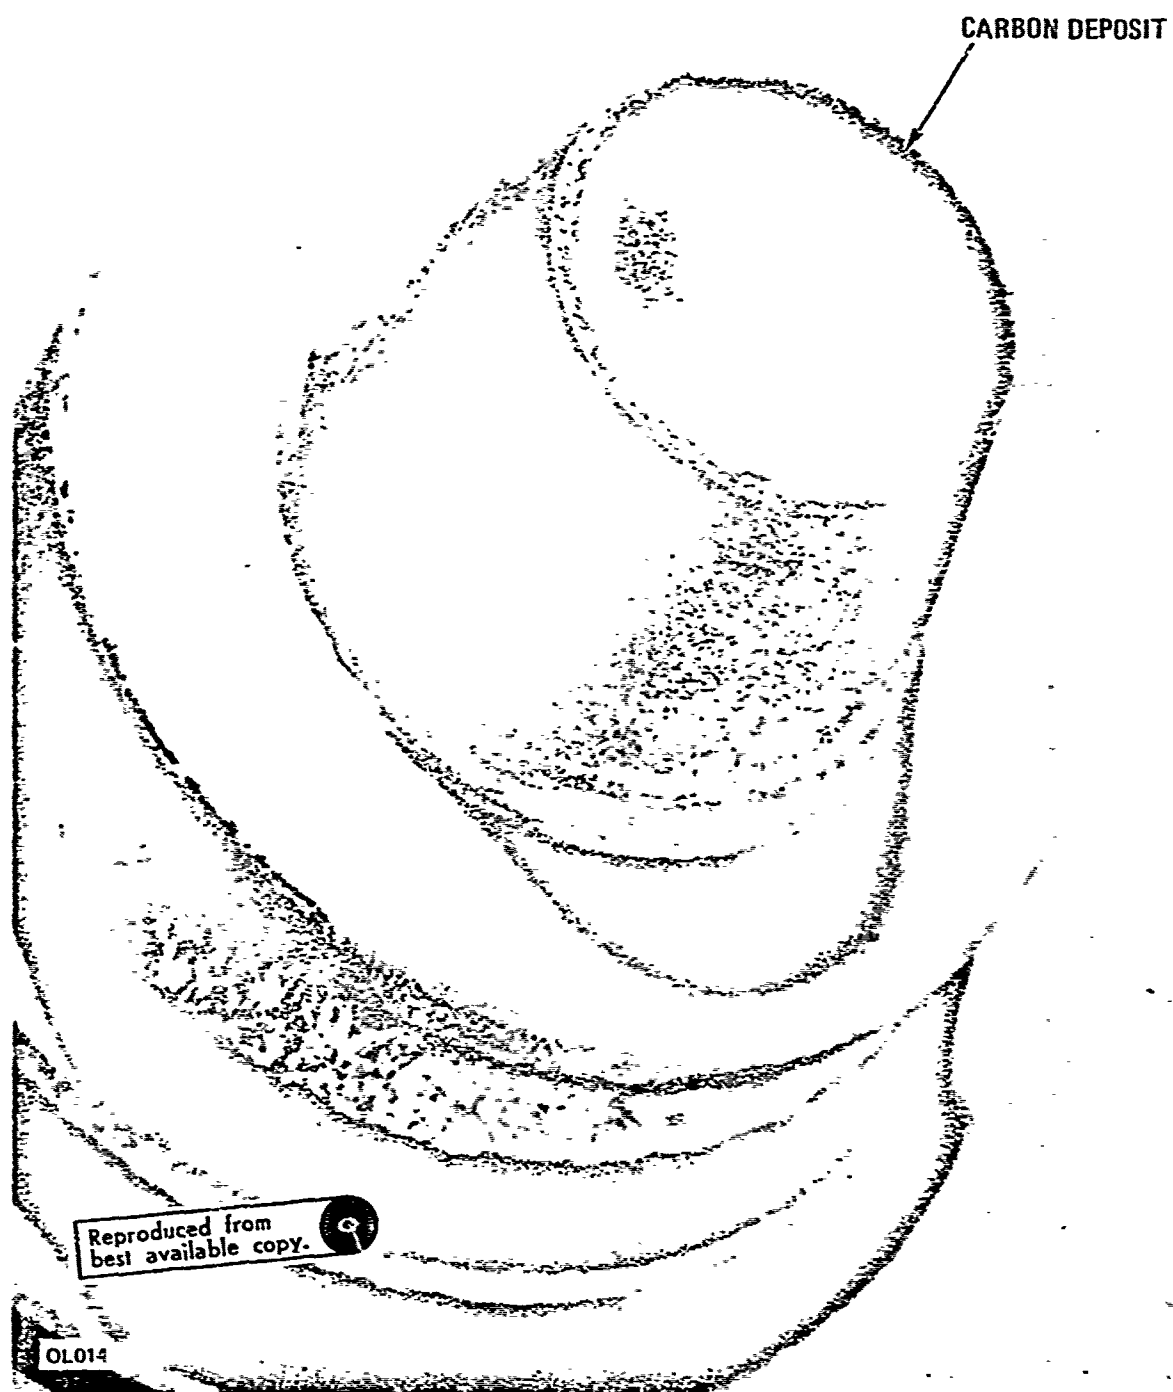
Figure 4-2. Carbon Deposit on Fuel Injector

- d. Fuel injector was removed and photographed (see Figure 4-2). Carbon buildup on nozzle was blocking fuel inlet ports (Figure 4-3). Replaced with new, factory tested injector assembly. Figure 4-4 illustrates a new injector nozzle for comparison with Figure 4-3.

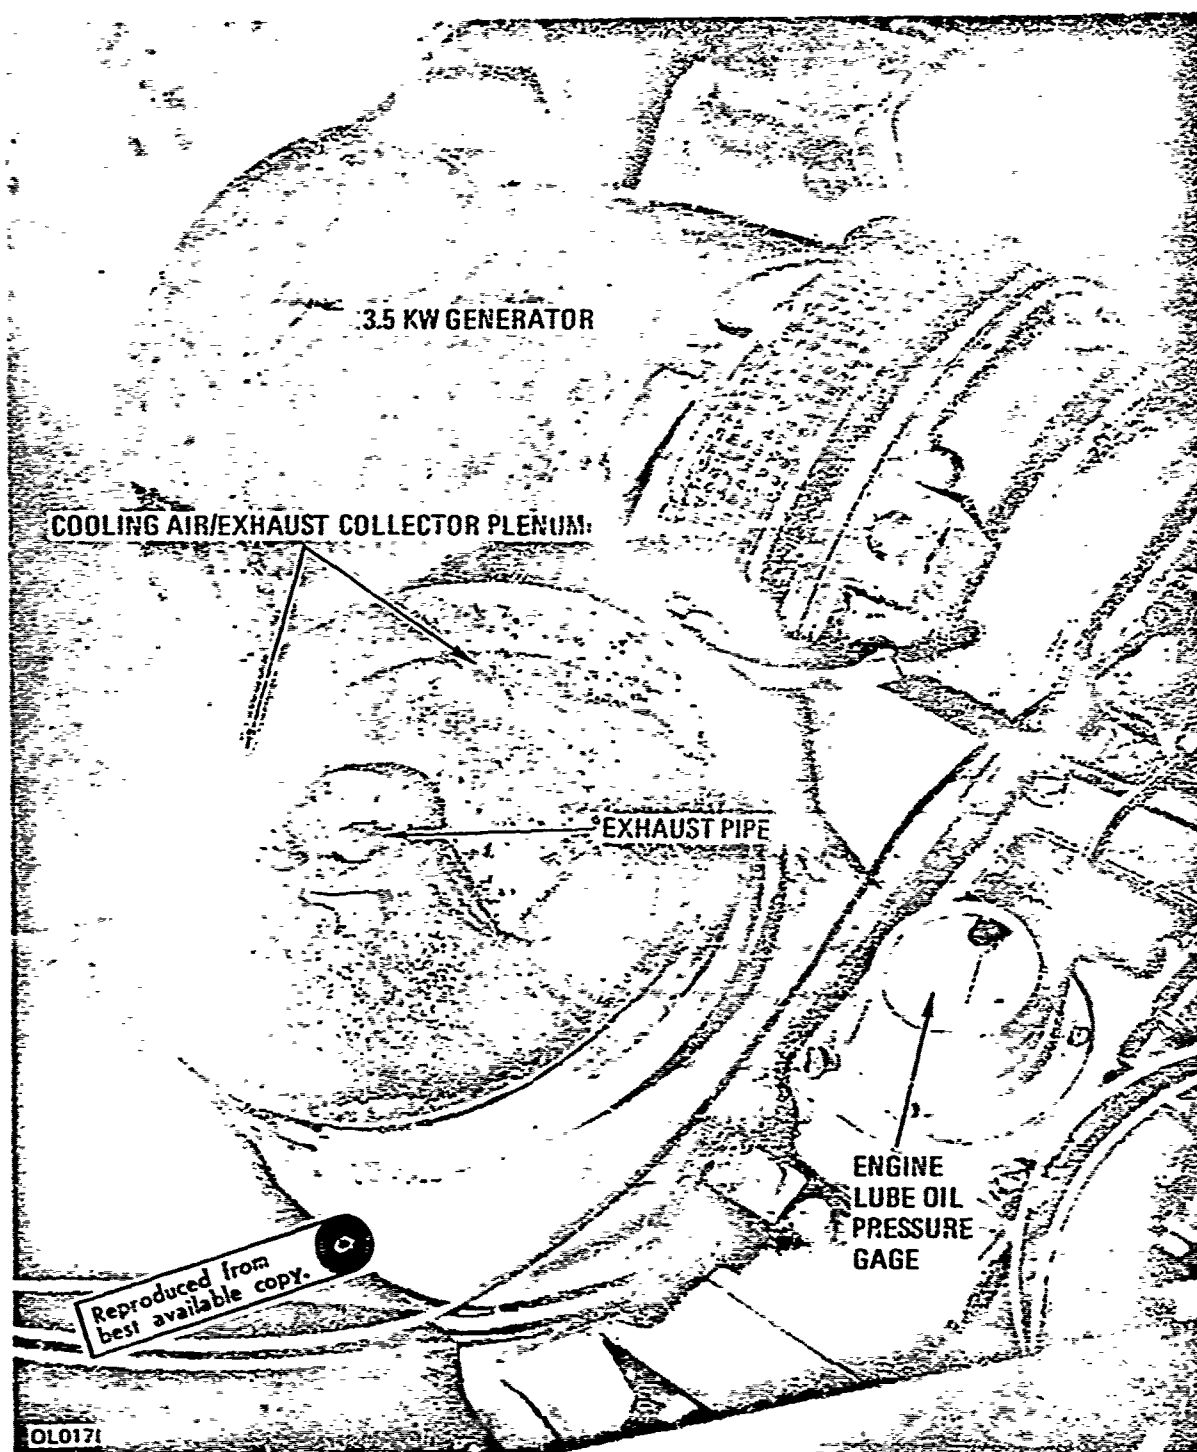
Figure 4-5. Carbon Buildup in Plenum

- e. Cleaned carbon deposits from exhaust plenum and combustion exhaust pipe.
- f. Took oil sample.
- g. Installed gasket on valve cover (none previously).
- h. General inspection of engine exterior for leaks and loose connections. Tightened nuts and bolts.

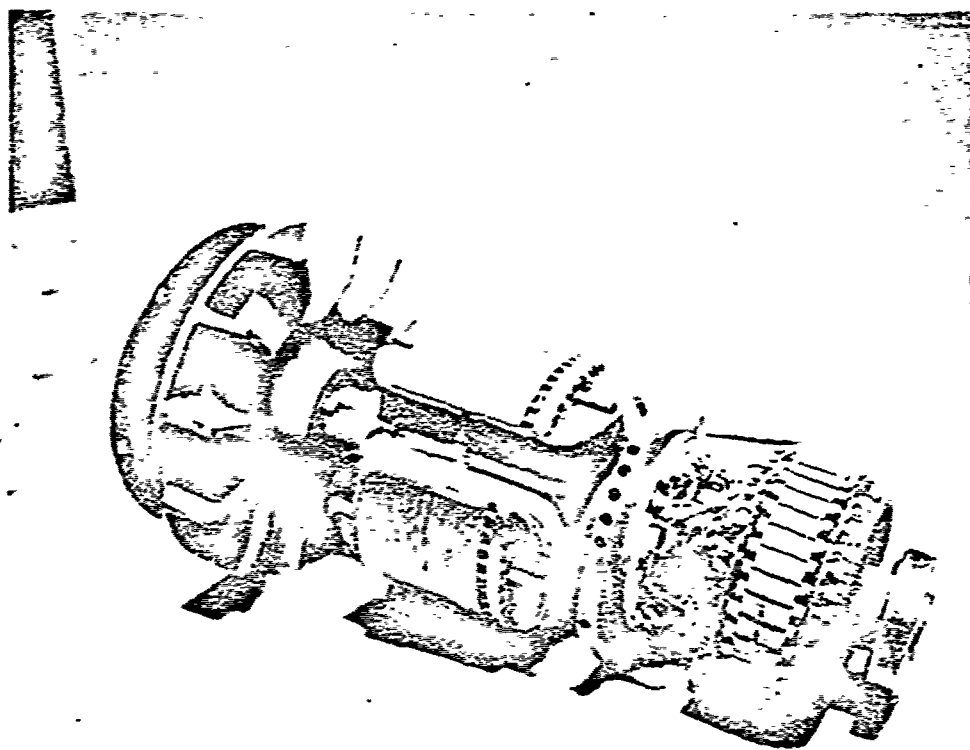
Figure 4-18. Alternator

An examination of the interior of the alternator disclosed that the only significant accumulation of foreign material (dust) was confined to the exciter end of the rotor assembly. This is shown at the right-hand side of Figure 4-18. There was no evidence of bearing seal deterioration or loss of bearing lubricant.

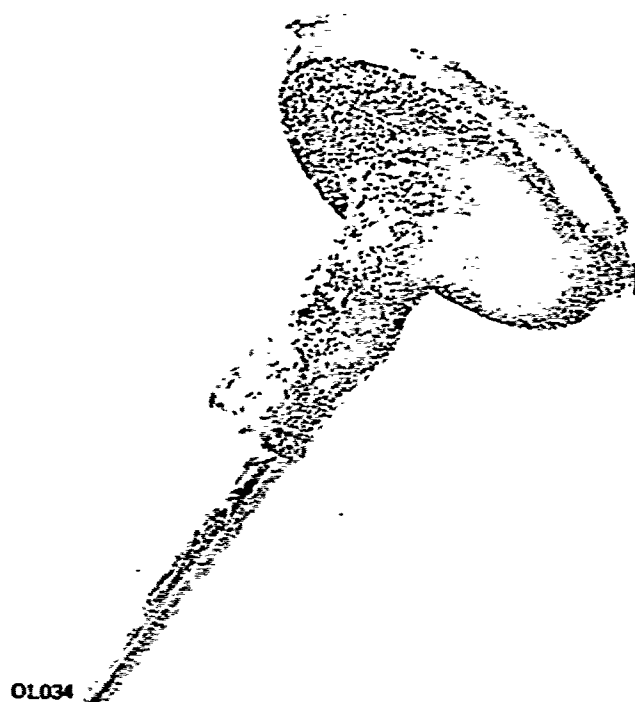
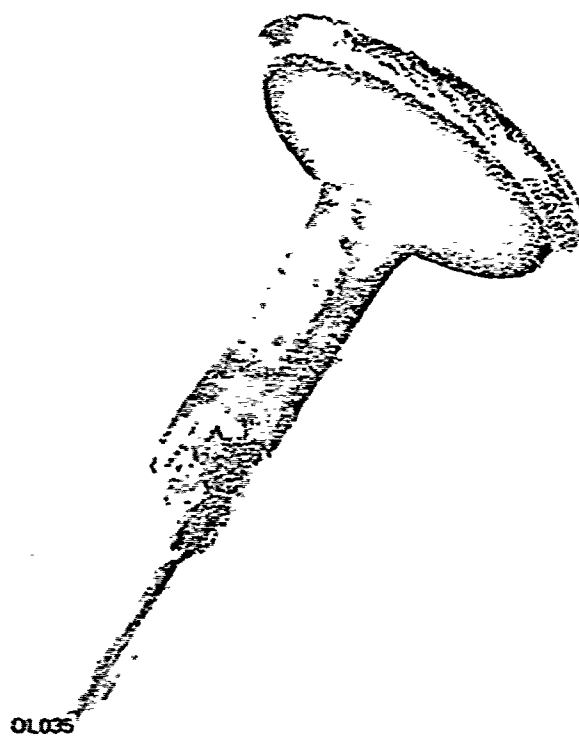
Initial examination of the visible surface of the valves disclosed no evidence of burning. Upon valve removal, considerable erosion of valve faces and seats was noted (see Figures 4-21, 4-22, and 4-23). Valve clearances were not examined during disassembly. However, the absence of burning and the fact that although eroded the valve and respective seat surfaces interfaced well, suggested that pounding as opposed to insufficient clearance was the likely cause. Valve stem, guide, and port deposits of carbon were light. Considering the period of operation, stem and guide wear were minimal, resulting in clearances not exceeding 0.006 inch.

- a. Replace valve guides.
- b. Re-surface valve seats.
- c. Install new valves.
- d. Re-grind rocker tappet surfaces.
- e. Install new oil pump cam follower.
- f. Re-surface valve cam followers.
- g. Fit new piston, ring set, wrist pin, and bushing.
- h. Metal-spray or hard-chrome-plate the crankshaft oil seal area to fill groove, and re-grind to standard size.
- i. Replace the oil seal.
- j. Install new connecting rod bearing set.

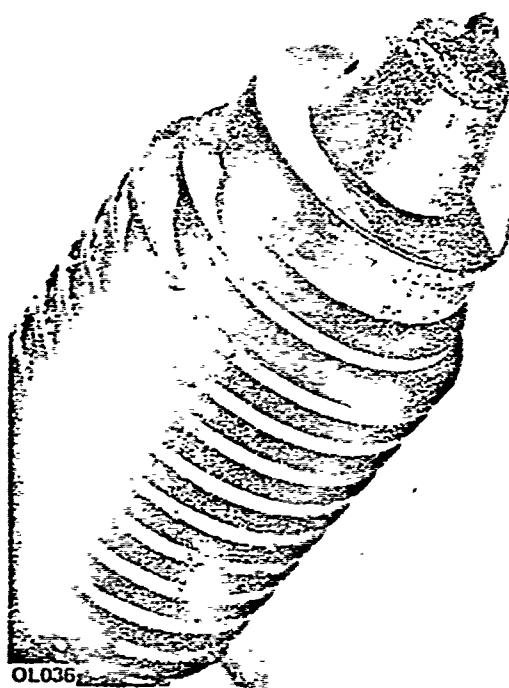
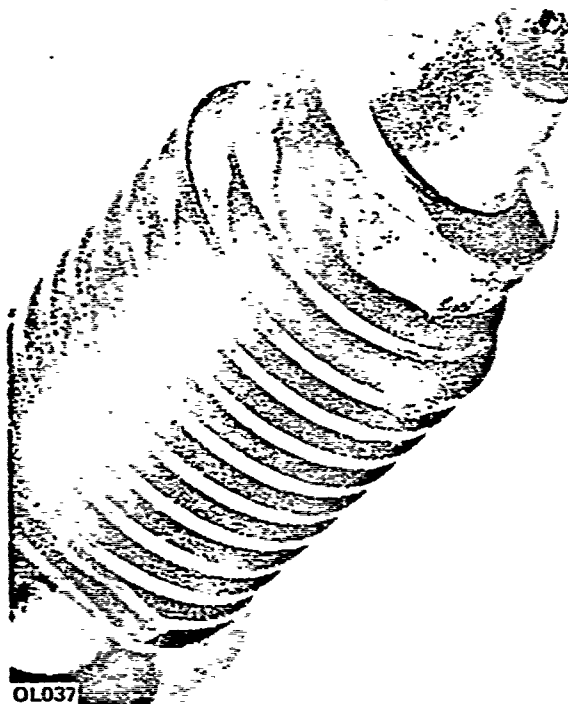
Inspection of the fuel injector assembly disclosed only minor deposition of carbon on the nozzle tip (Figures 4-24 and 4-25). Pressure testing of the unit showed no visible leakage. Cracking and seating pressures were within acceptable limits. However, a discrepancy was noted in the spray pattern as shown in Figure 4-26. One of the 120° spaced orifices was completely blocked, one appeared nearly normal, and the third was greatly enlarged as shown at the right-hand side of Figure 4-26.

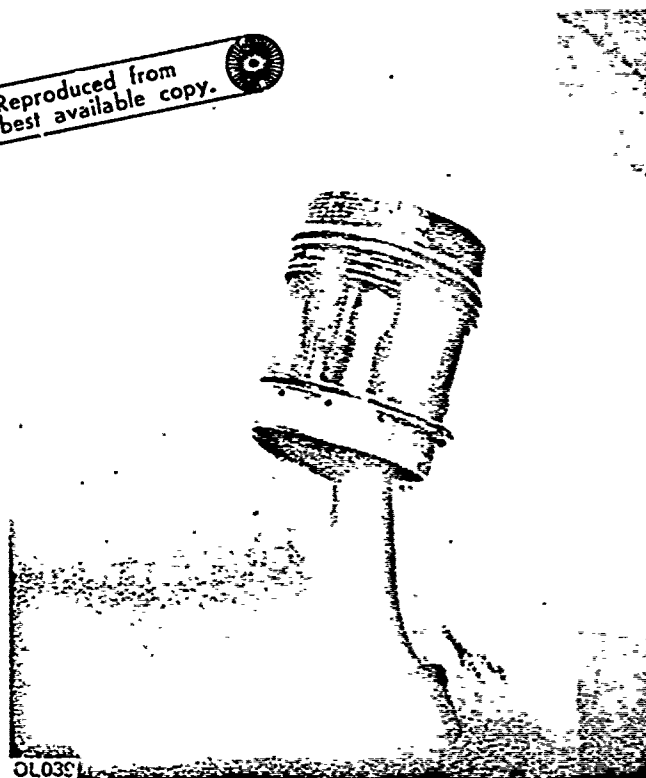
Figure 4-27. Piston Assembly

Piston Assembly and Cylinder Barrel - Carbon buildup on the piston assembly was found to be relatively light (Figure 4-27). All rings were intact, and free in their respective grooves. Buildup in the oil control rings and associated return passages was insufficient to impair their effectiveness. Maximum evidence of ring wear

was exhibited by the wedge cross-sectioned firing ring (upper compression ring) which had developed an approximate 0.005-inch concave upper surface. Ring land wear associated with the firing ring and the second compression ring would normally preclude re-use of the piston without re-machining and installation of oversize rings. Maximum ring butt clearance encountered was 0.020 inch. Minimum clearance was 0.016 inch.
